## SITE INSPECTION MEMO

**To:** Mr. Matthew Benoit, Director of Community Development  
**From:** Douglas W. Bush, P.E., Haley Ward  
**Re:** Construction Monitoring – Oak Street Solar, 45 Oak Street, Douglas, MA  
**Date:** December 12, 2023

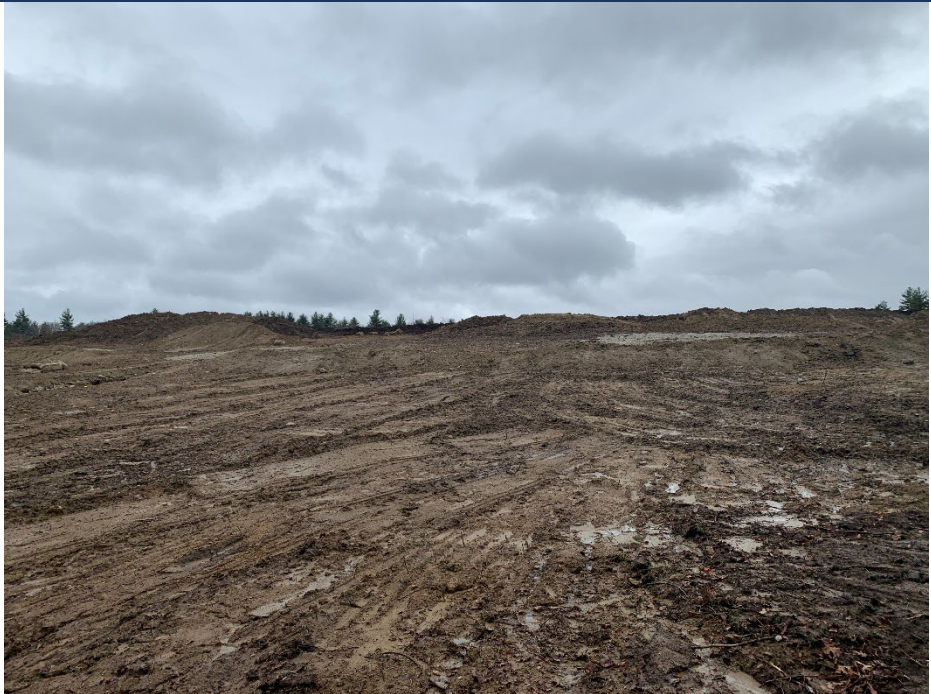
<b>Photo No. 3</b>

The erosion controls in the northeast corner have become completely inundated with silt which has allowed sediment laden runoff to flow into the downstream wooded area unimpeded. The entire site upgradient of this corner has not been stabilized nor has a temporary basin been installed as previously requested which has caused sediment to overwhelm the erosion controls. In addition, discharge was observed entering Manchaug Pond approximately 0.5 miles downstream.

<b>Photo Date:</b> 12/11/23	
<b>Site Location:</b> 45 Oak Street	
<b>Description:</b> Unstabilized area of the northeast corner.	
<b>Photo By:</b> DWB

***Immediately install a temporary sedimentation basin as outlined in the construction sequencing note #7 as shown on sheet C-301. Immediately stabilize the upstream surrounding area of this corner to minimize the transfer of additional sediment downstream. The mulch berms upstream of infiltration basin-5 do not appear to be properly removing sediment. Haley Ward suggests that additional erosion controls (i.e. silt fence, mulch berms, straw wattles, straw bales, silt socks, etc.) be placed at all disturbed areas. Spacing of the intermediate erosion controls shall be placed per applicable MassDEP and manufacturer requirements. The phasing plan should be evaluated, and it is likely that smaller areas of disturbance per phase are needed given the issues occurring at the site.***

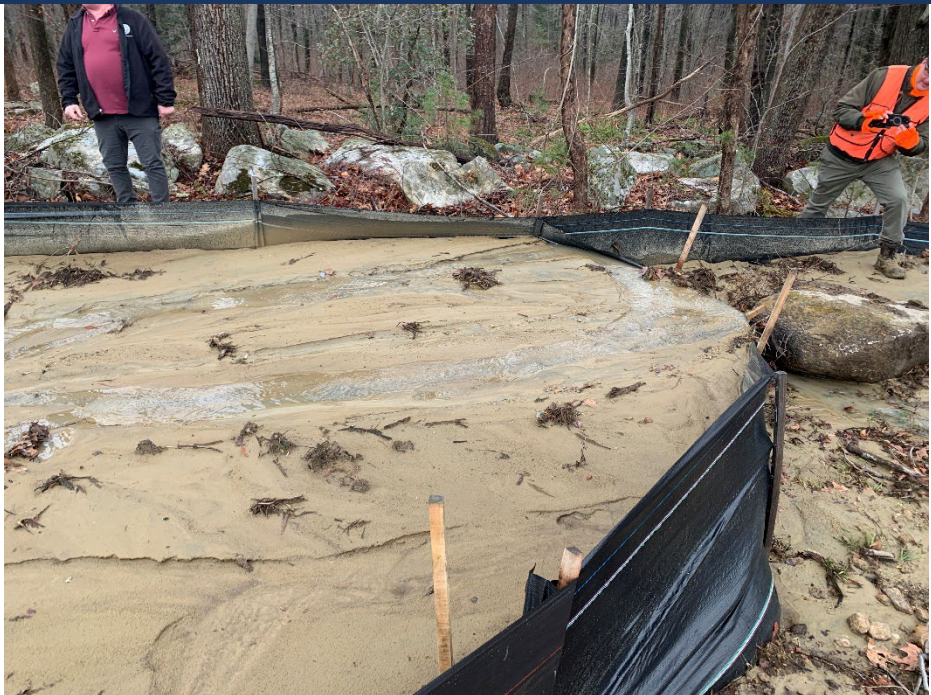
<b>Photo No. 4</b>

<b>Photo Date:</b> 12/11/23	
<b>Site Location:</b> 45 Oak Street	
<b>Description:</b> Silt fencing inundated with sediment. Photo along northern line upgradient of NE corner.	
<b>Photo By:</b> DWB
