### *SITE INSPECTION MEMO*

**Date:** December 11, 2023

**Re:** Construction Period Inspections – Oak Street Solar, 45 Oak Street, Douglas, MA (DEP File No. 143-0989)

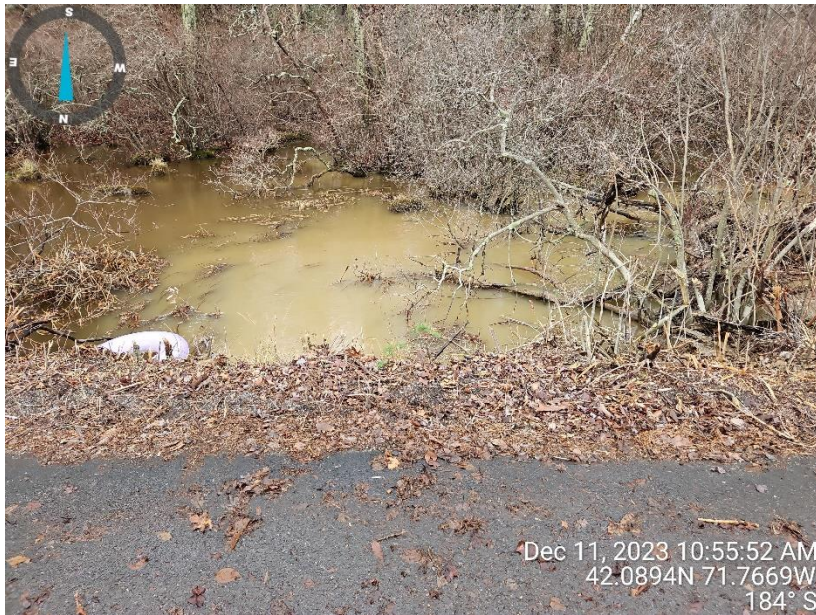
1. Wetland on south side of Holt Road culvert in Sutton (across from Manchaug Pond)

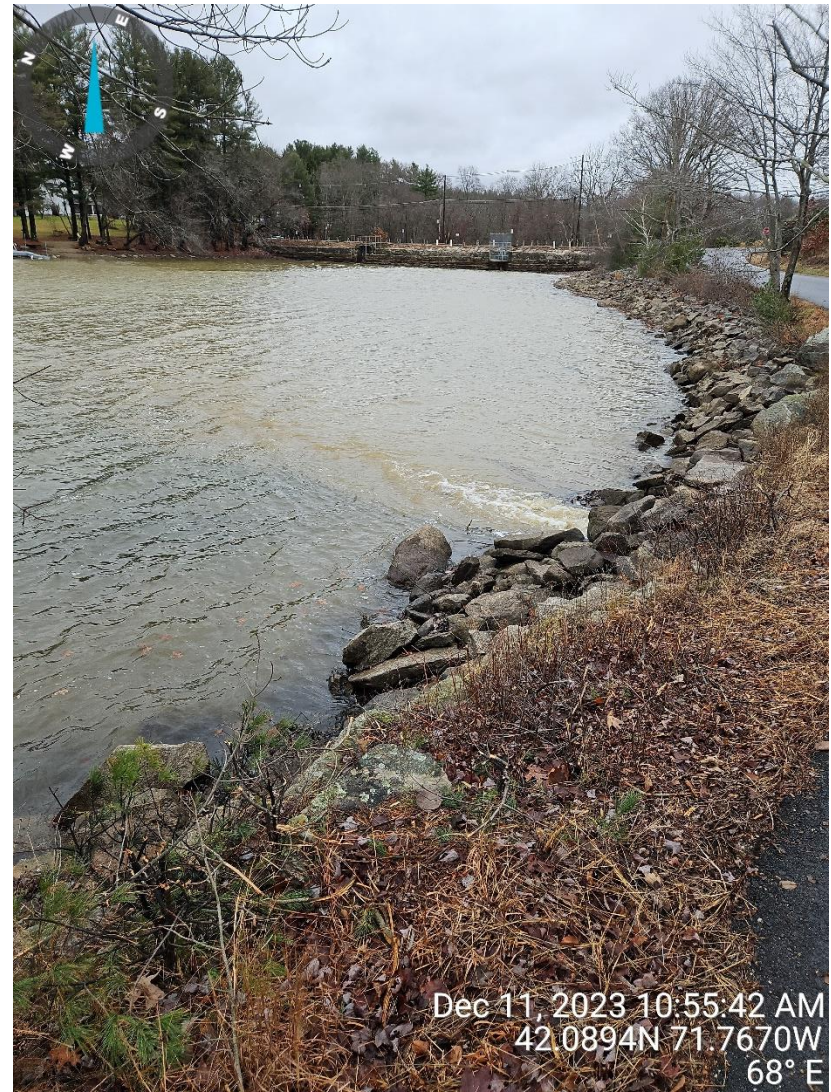
2. Manchaug Pond on north side of Holt Road culvert in Sutton

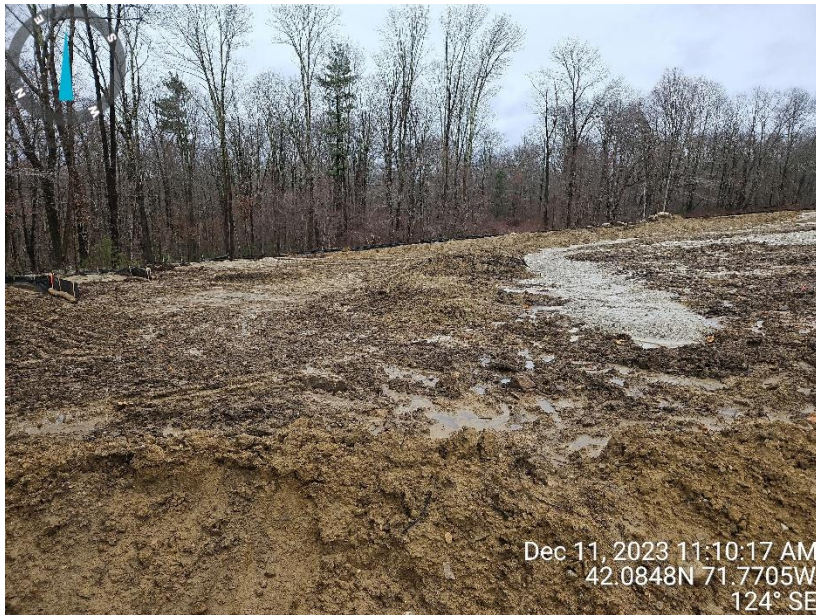
3. Vicinity Basin-5, north corner of 45 Oak Street

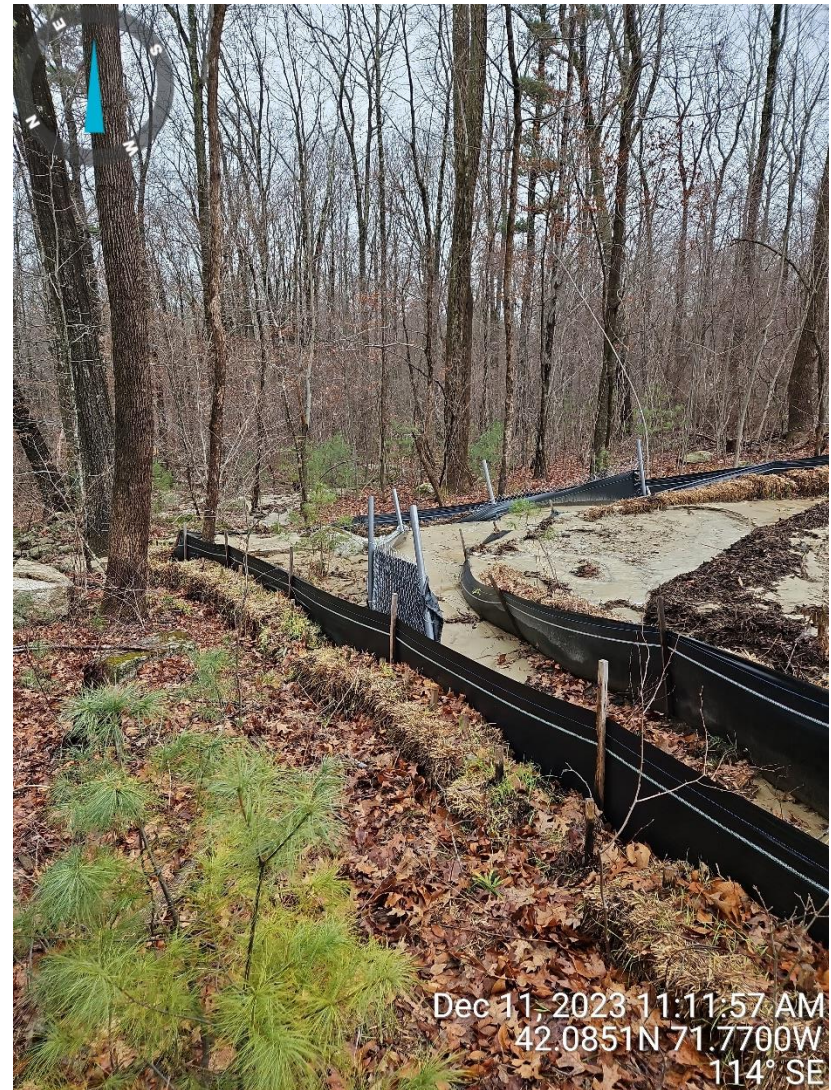
Soils within Phase 3 were largely exposed during the recent rain event and significant erosion occurred. In places the erosion extended down to, and into, to the underlying glacial hardpan. The perimeter controls, berms and swales in place at the time of the rain event proved largely ineffective in stopping sediment runoff from leaving the site. As depicted in the attached photos, sediment-laden runoff was flowing over and through the perimeter controls, into Sutton, over several downgradient properties and into Manchaug Pond. A large plume of turbid water was observed within Manchaug Pond. Off-site sediment deposits were noted which require further assessment and cleanup. A protocol for off-site cleanup should be submitted for review. On-site siltation controls should be cleaned and repaired as soon as possible. Additional on-site control and stabilization measures are needed.

4. North corner at sediment discharge point

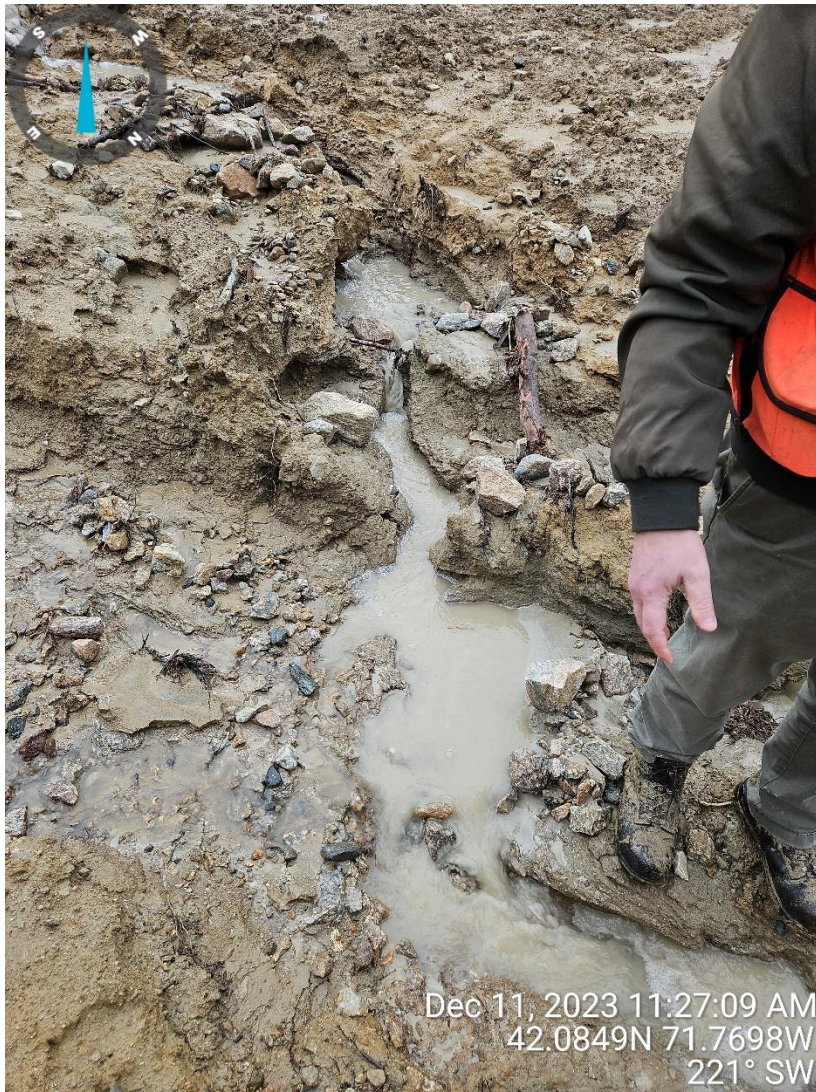
5. Erosion of overburden soils down to, and into, glacial hardpan (north corner of site)

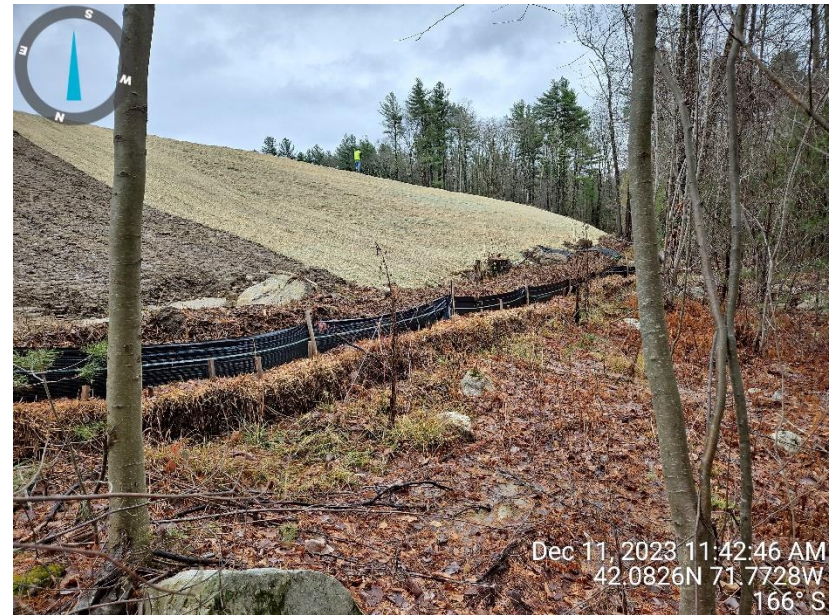
6. Basin-2 stabilization
