EcoTec, Inc.

SITE INSPECTION MEMO

Date: December 18, 2023

Re: Construction Period Inspections – Oak Street Solar, 45 Oak Street, Douglas, MA (DEP File No. 143-0989)

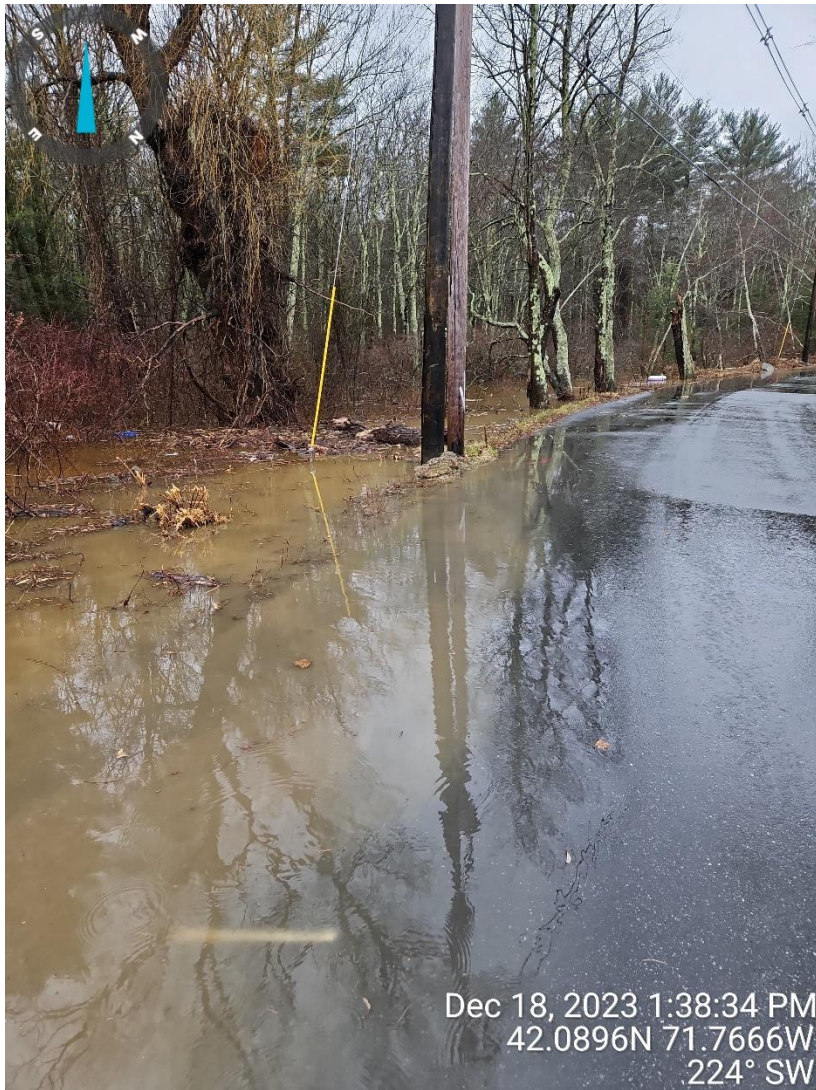
1. Wetland on south side of Holt Road culvert in Sutton (across from Manchaug Pond)

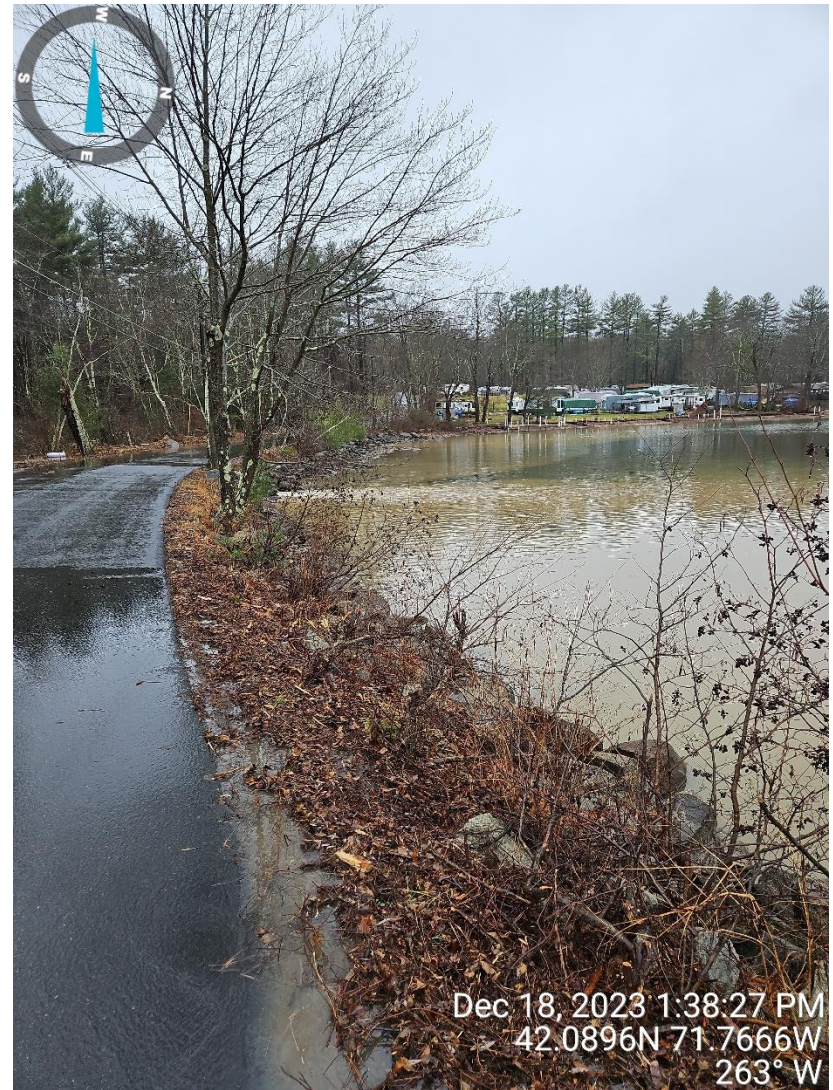
2. Manchaug Pond on north side of Holt Road culvert in Sutton

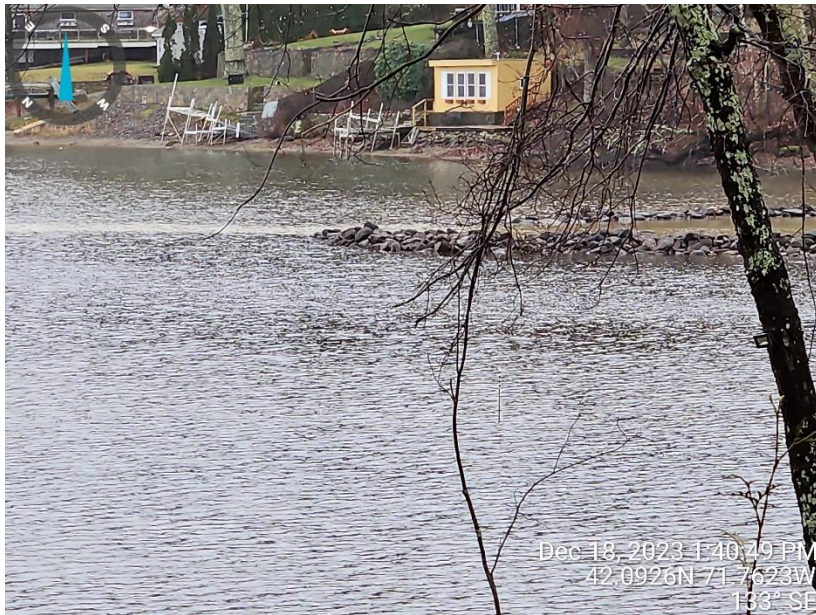
3. Stevens Pond (downstream from Manchaug Pond)

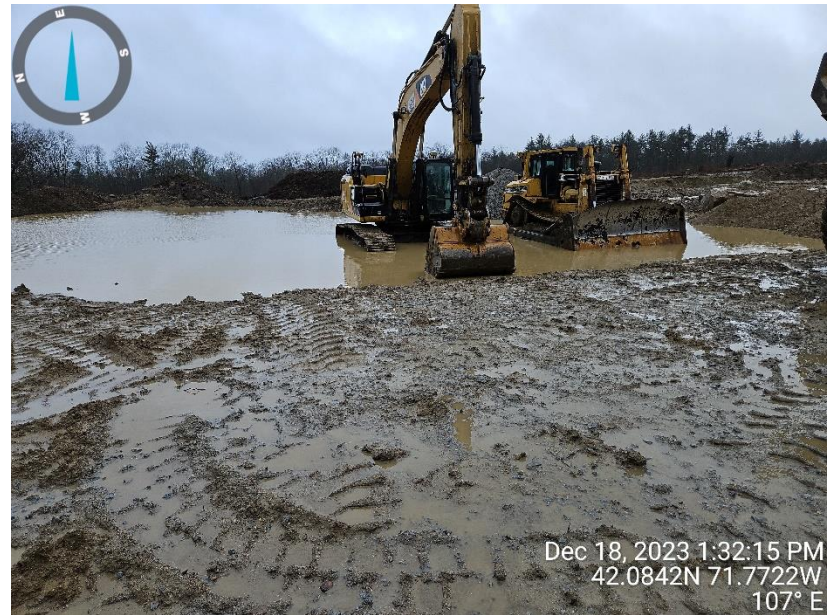
5. Top of site

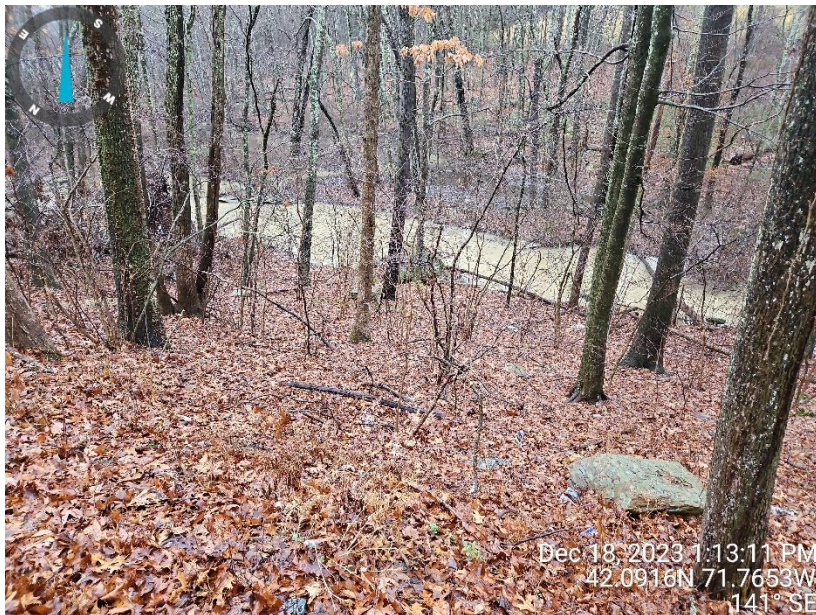
4. River between Manchaug & Stevens Ponds

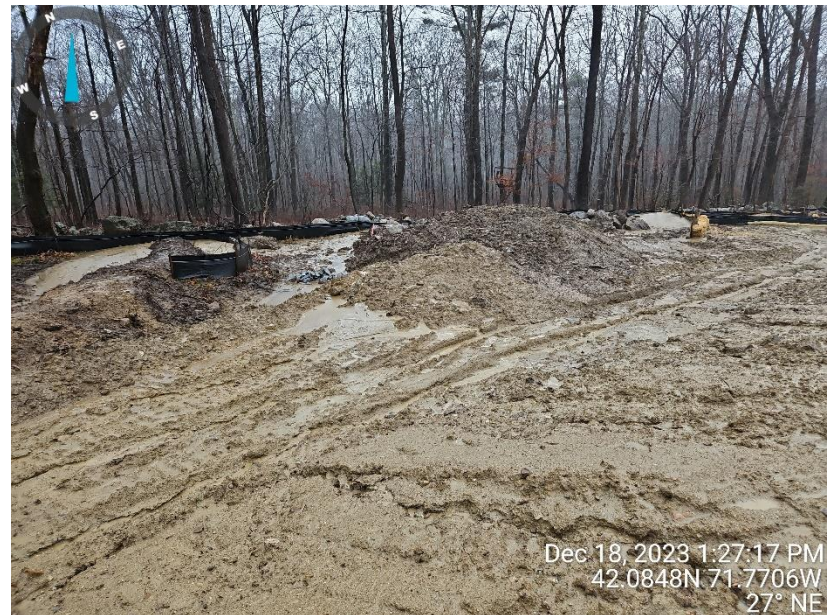
6. Flow across Phase 5

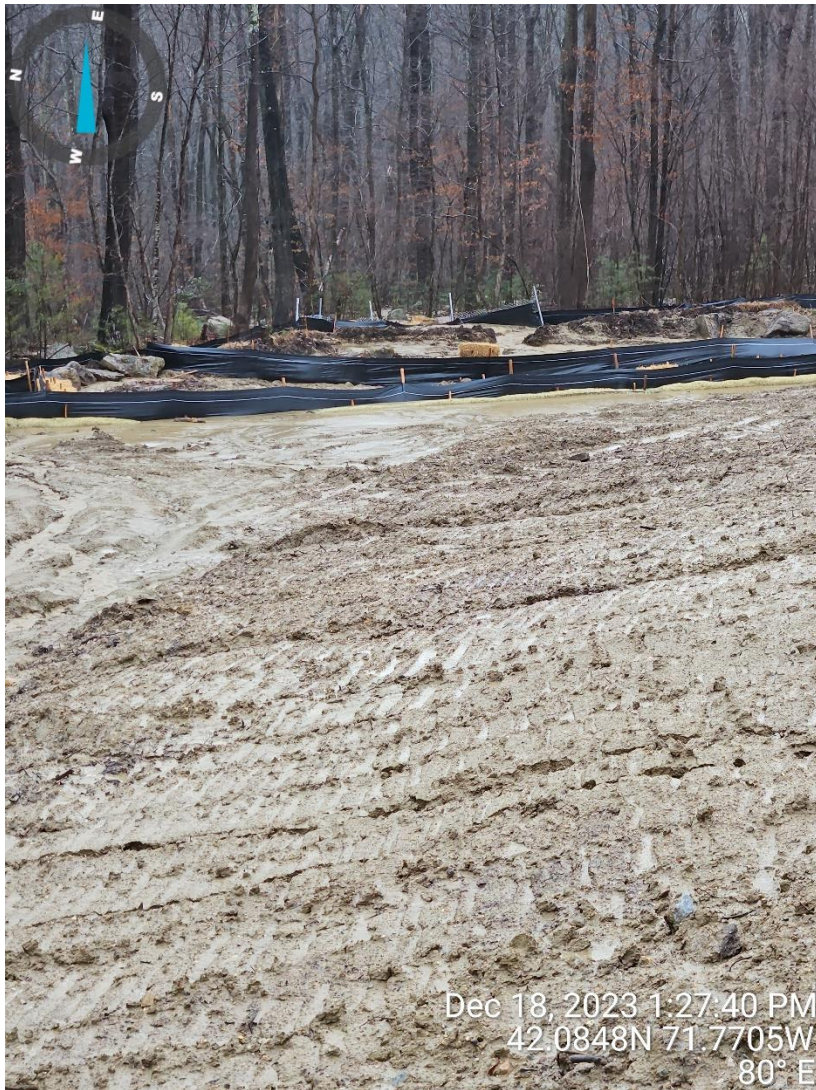
7. North corner discharge point in Phase 5

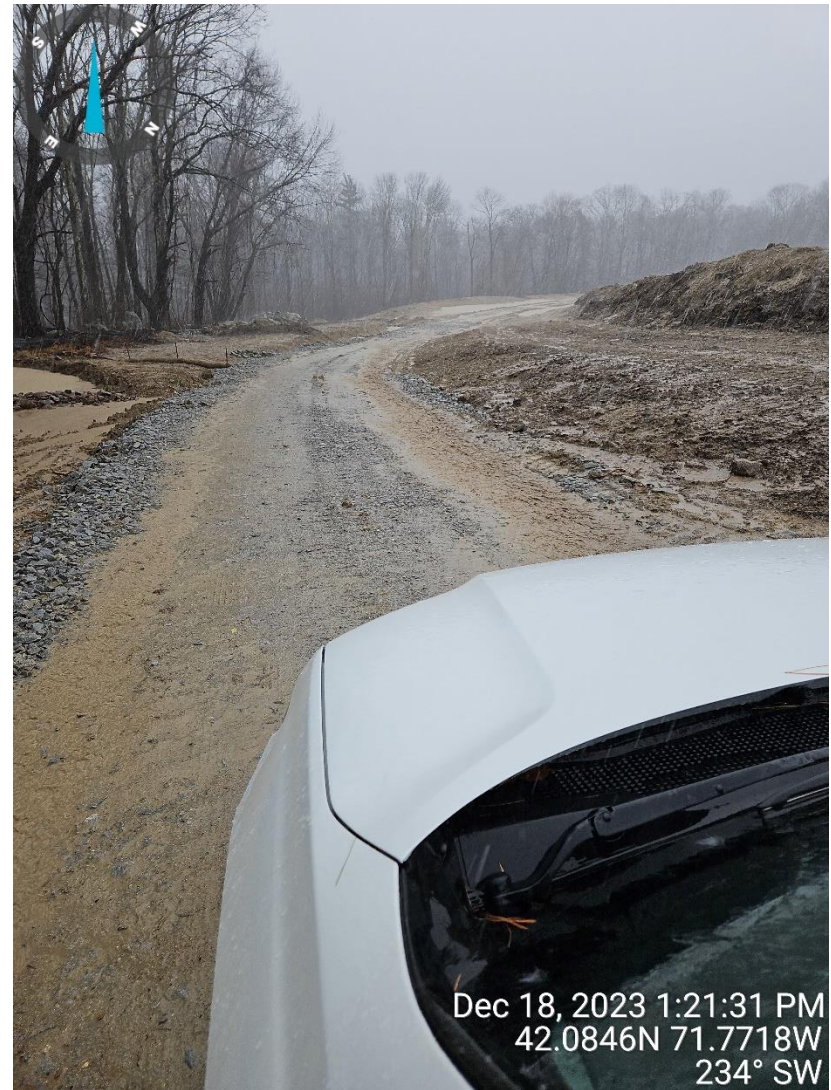
8. Access road to Basin-5
